Manhole Inspection Summary

Manhole # S27M1_007MH

Location Address: **1001 Shellbanks Road**

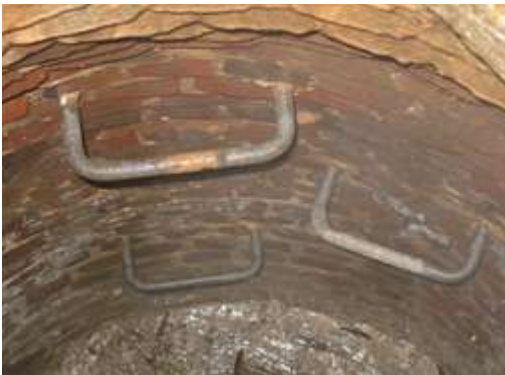
Steps

Count: **3** Missing: **0** ☐ Corroded

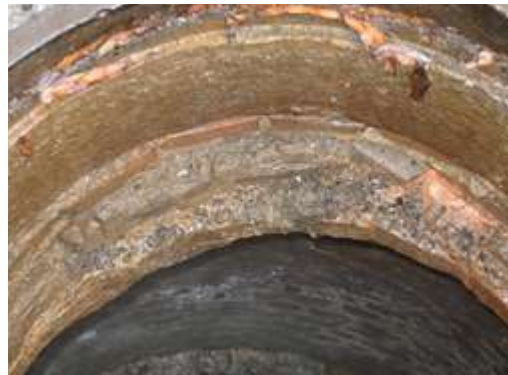
Defect 1

Offset: **4** (in.)

Frame offset

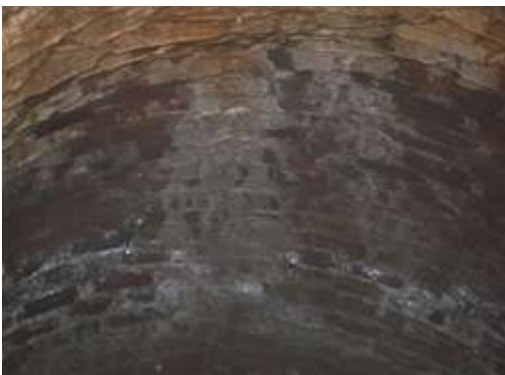
Defect 2

Infiltration: ☐ None ☐ Joint ☐ Cracks ☐ Mortar ☐ Roots ☒ Wall

Wall

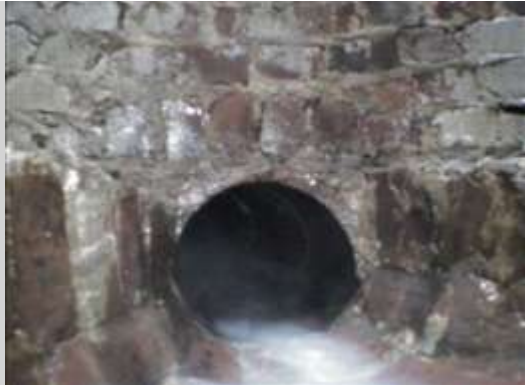
12 O'Clock Outflow

8 in. Circular Gravity Sewer
Pipe Out @ 12 O'Clock

Pipe Height: **9.6** (in.) Rod and Bar (Angled)
Pipe Material: **Clay** ☐ Pipe Lined
Invert Depth: **8.27** (ft.) Flow Characteristics: **Fast**
Deposits: ☒ None ☐ Mud ☐ Sludge ☐ Debris ☐ Grease
Silt Depth: (in.) Deposits Extent:
Infiltration: **None** Pipe Seal Cond: **Sound**

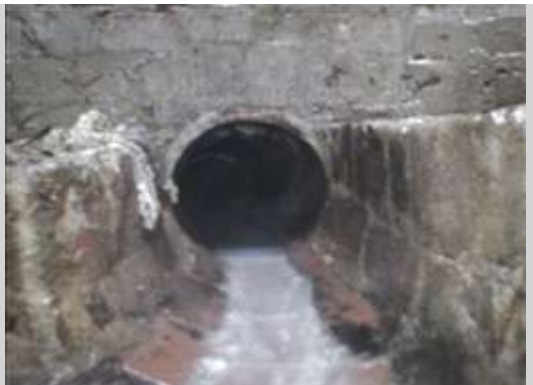
3 O'Clock Inflow

8 in. Circular Gravity Sewer
Pipe In @ 3 O'Clock

Pipe Height: **9.6** (in.) Rod and Bar (Angled)
Pipe Material: **Clay** ☐ Pipe Lined
Invert Depth: **7.80** (ft.) Flow Characteristics: **Fast**
Deposits: ☒ None ☐ Mud ☐ Sludge ☐ Debris ☐ Grease
Silt Depth: (in.) Deposits Extent:
Infiltration: **None** Pipe Seal Cond: **Sound**

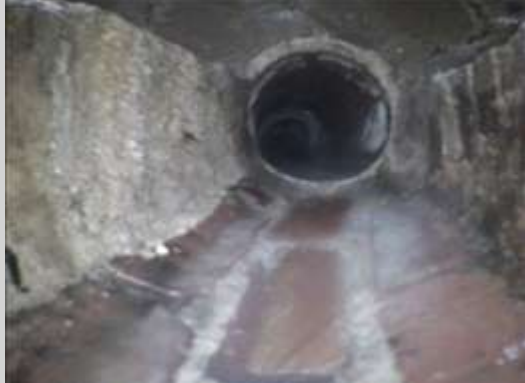
7 O'Clock Inflow

6 in. Circular Gravity Sewer

Pipe In @ 7 O'Clock

Infiltration: **None**

Pipe Seal Cond: **Sound**
